Concrete Resurfacing or Whitetopping

Thin Composite Concrete Overlays

Thin Concrete Overlays Performance Review 2018

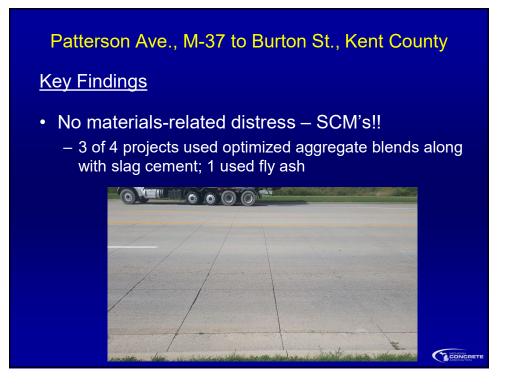
Patterson Ave., M-37 to Burton St., Kent County

- Repairs performed in 2016
 - Less than 3% of total original area
 - Added expansion joints; Some blowups / breakup due to shifting slabs from <u>unsealed joints</u>

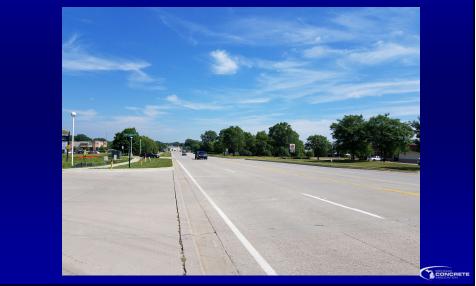
Zeeb Road, Jackson Rd. to Park Rd. Ann Arbor, 2018

- Overall Good condition, good ride.
- Few visible corner cracks and longitudinal cracks on south end
- Some light staining/shadowing visible near cracks.
- 2015 some full depth joint repairs as well as repairs done at intersection of transverse and longitudinal joints.
- Lots of trucks!

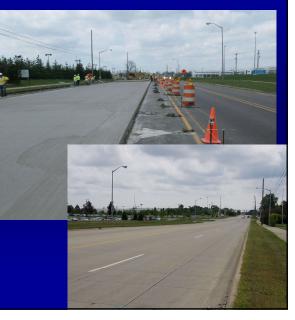
South Blvd., MLK to Opdyke, Pontiac

- Overall fair to good condition
- Poor to fair ride due to faulting and shifting panels.
- Several areas throughout project shattered slabs are visible
- Several blow ups have occurred on this pavement and full depth repairs done, expansion joint established.
- Visible chipping of joint saw cut in many areas.
- No MRD visible
